IN THE MATTER OF THE APPLICATION
OF TUSAYAN WATER DEVELOPMENT
ASSOCIATION, INC. FOR
ESTABLISHMENT OF RATES FOR
WATER SERVICE

**DIRECT TESTIMONY OF
RAY L. JONES**

Tusayan Municipal Water Study

July 26, 2011

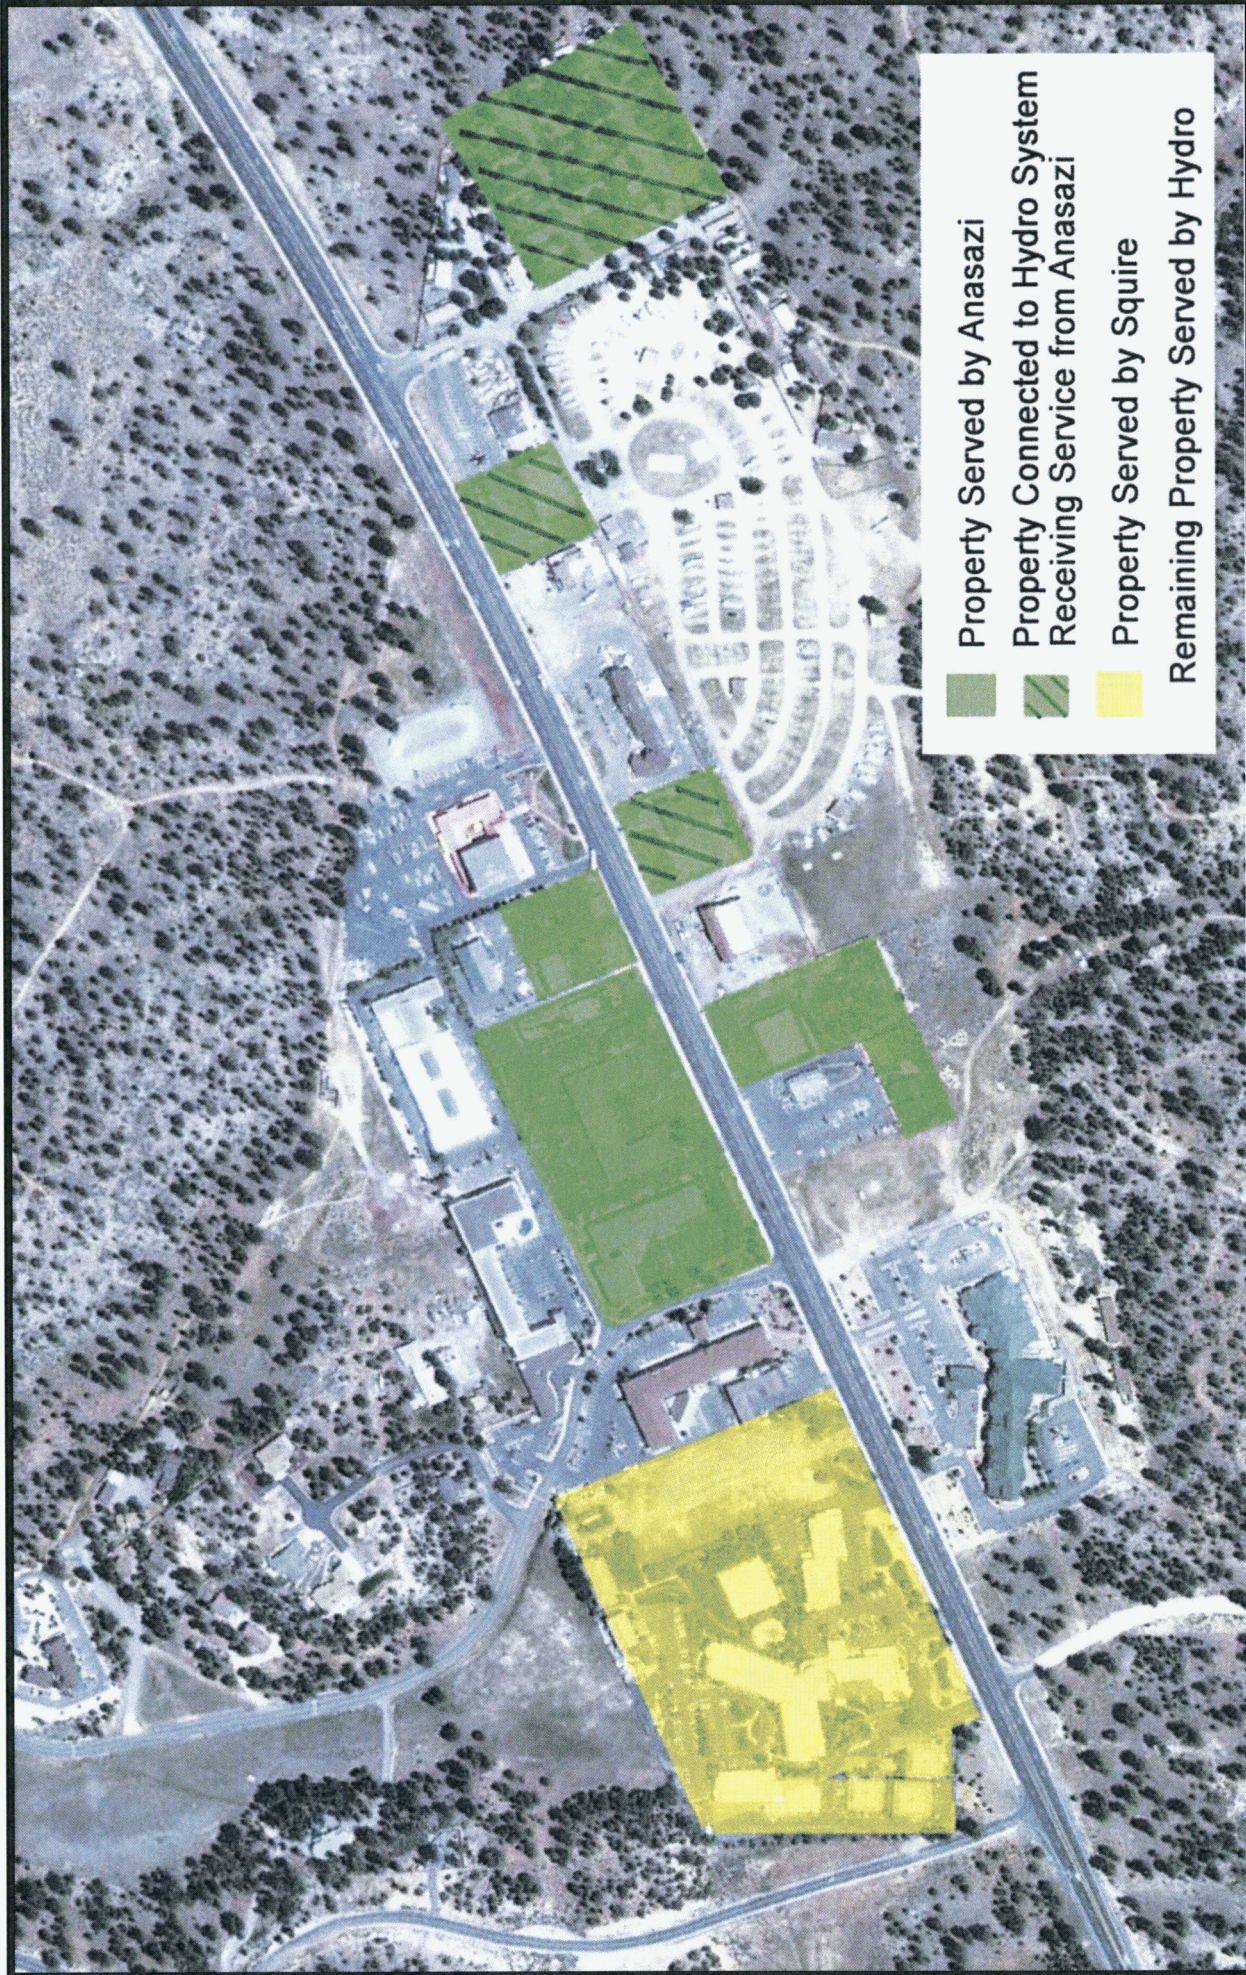
- Property Served by Anasazi
- Property Connected to Hydro System Receiving Service from Anasazi
- Property Served by Squire
- Remaining Property Served by Hydro

The Anasazi distribution system consists of PVC piping believed to be primarily 8" diameter (See Figure 2) with a 2" PE line connecting the well to the storage tank and an isolated section of 2" PVC that is interconnected with the Hydro distribution system. Anasazi reports that the 8" piping was replaced with new piping in 2002. Table 9 provides a summary of the distribution system components.

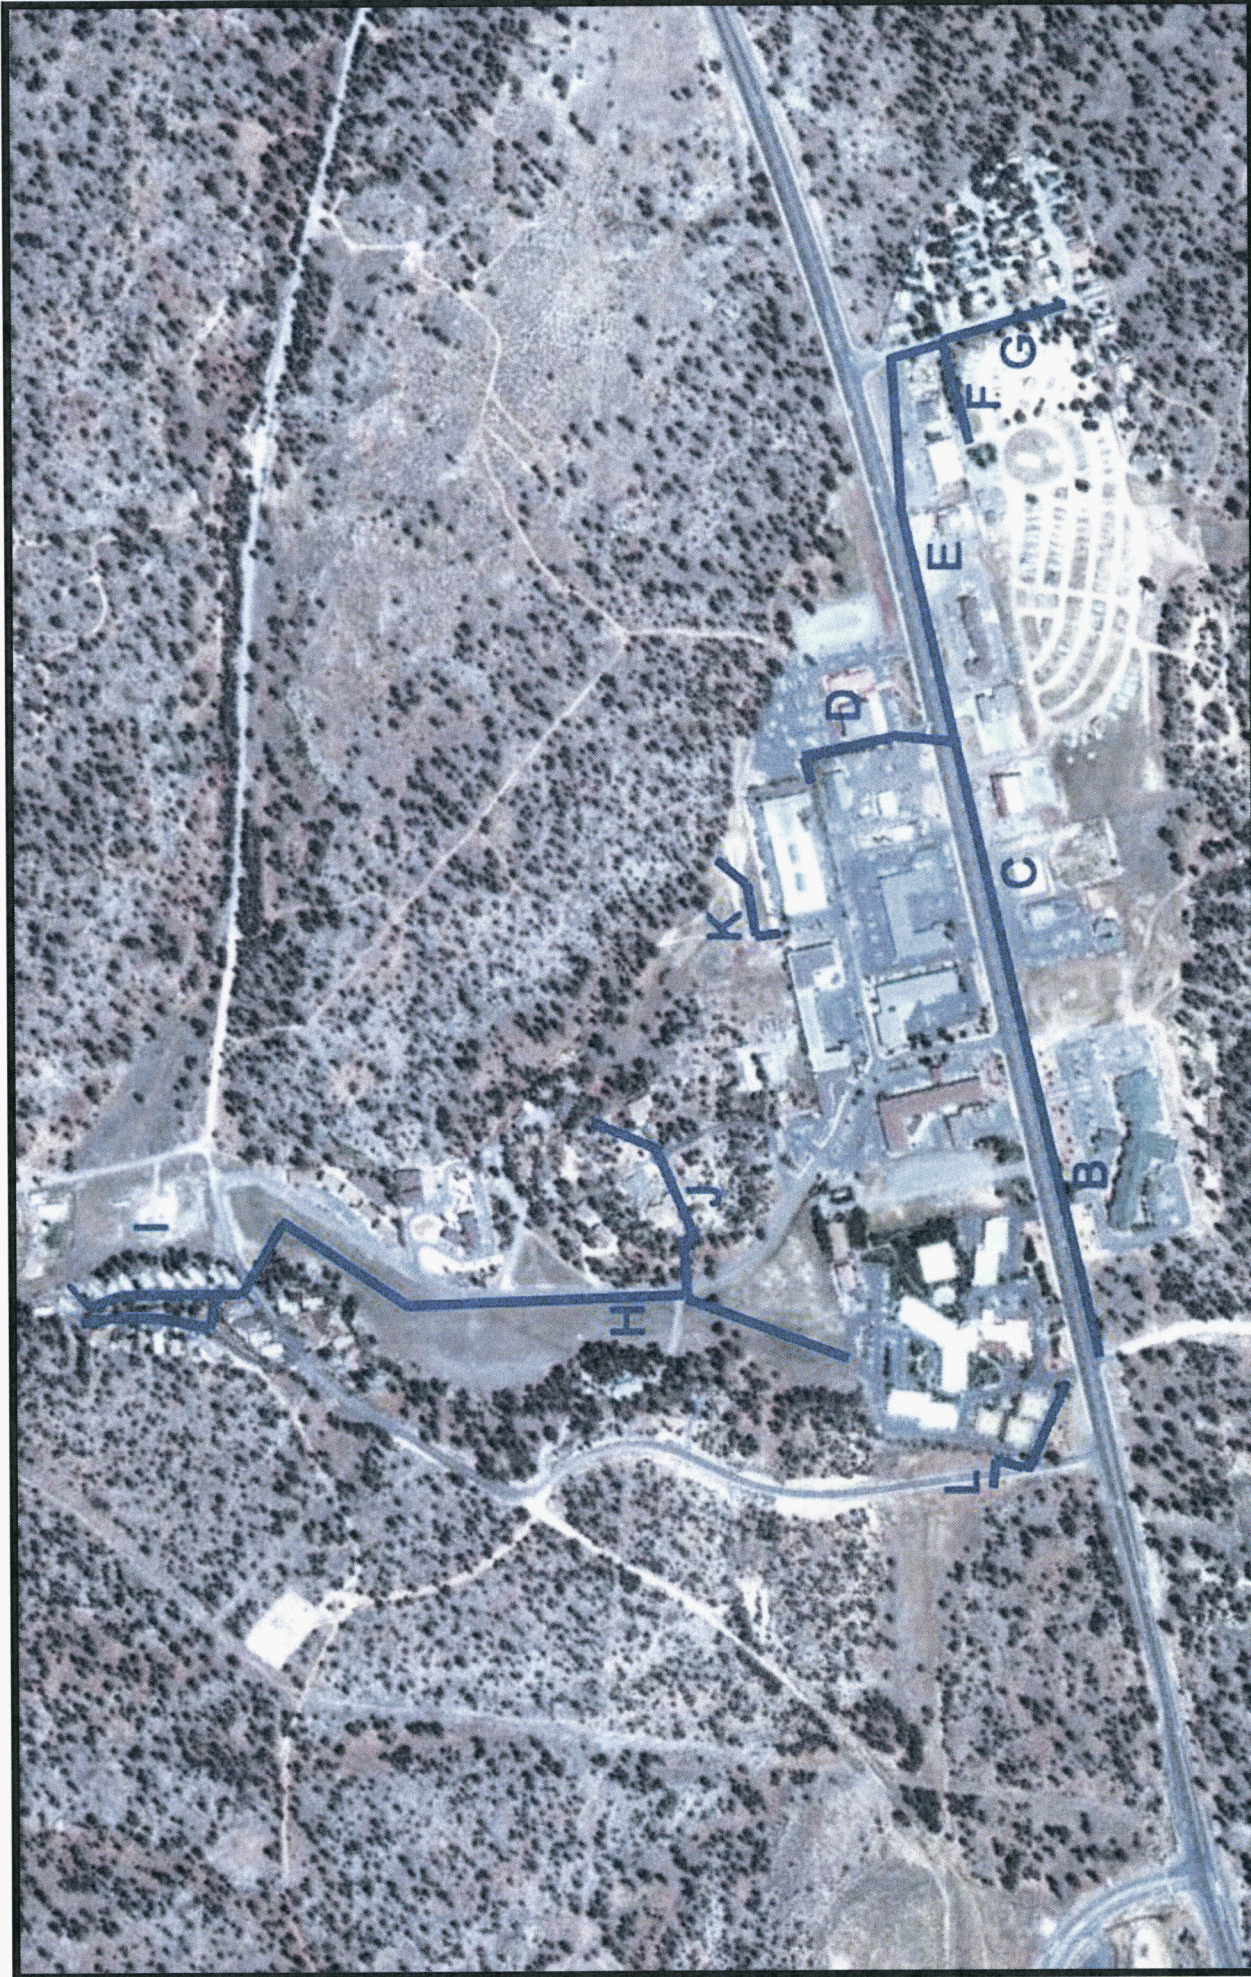
4

Hydro-Resources, Inc. – Distribution Segments
